Thank you for attending the Public Hearing for the 2019 Annual Groundwater Report

Fort Bend Subsidence District

2019 Annual Groundwater Report

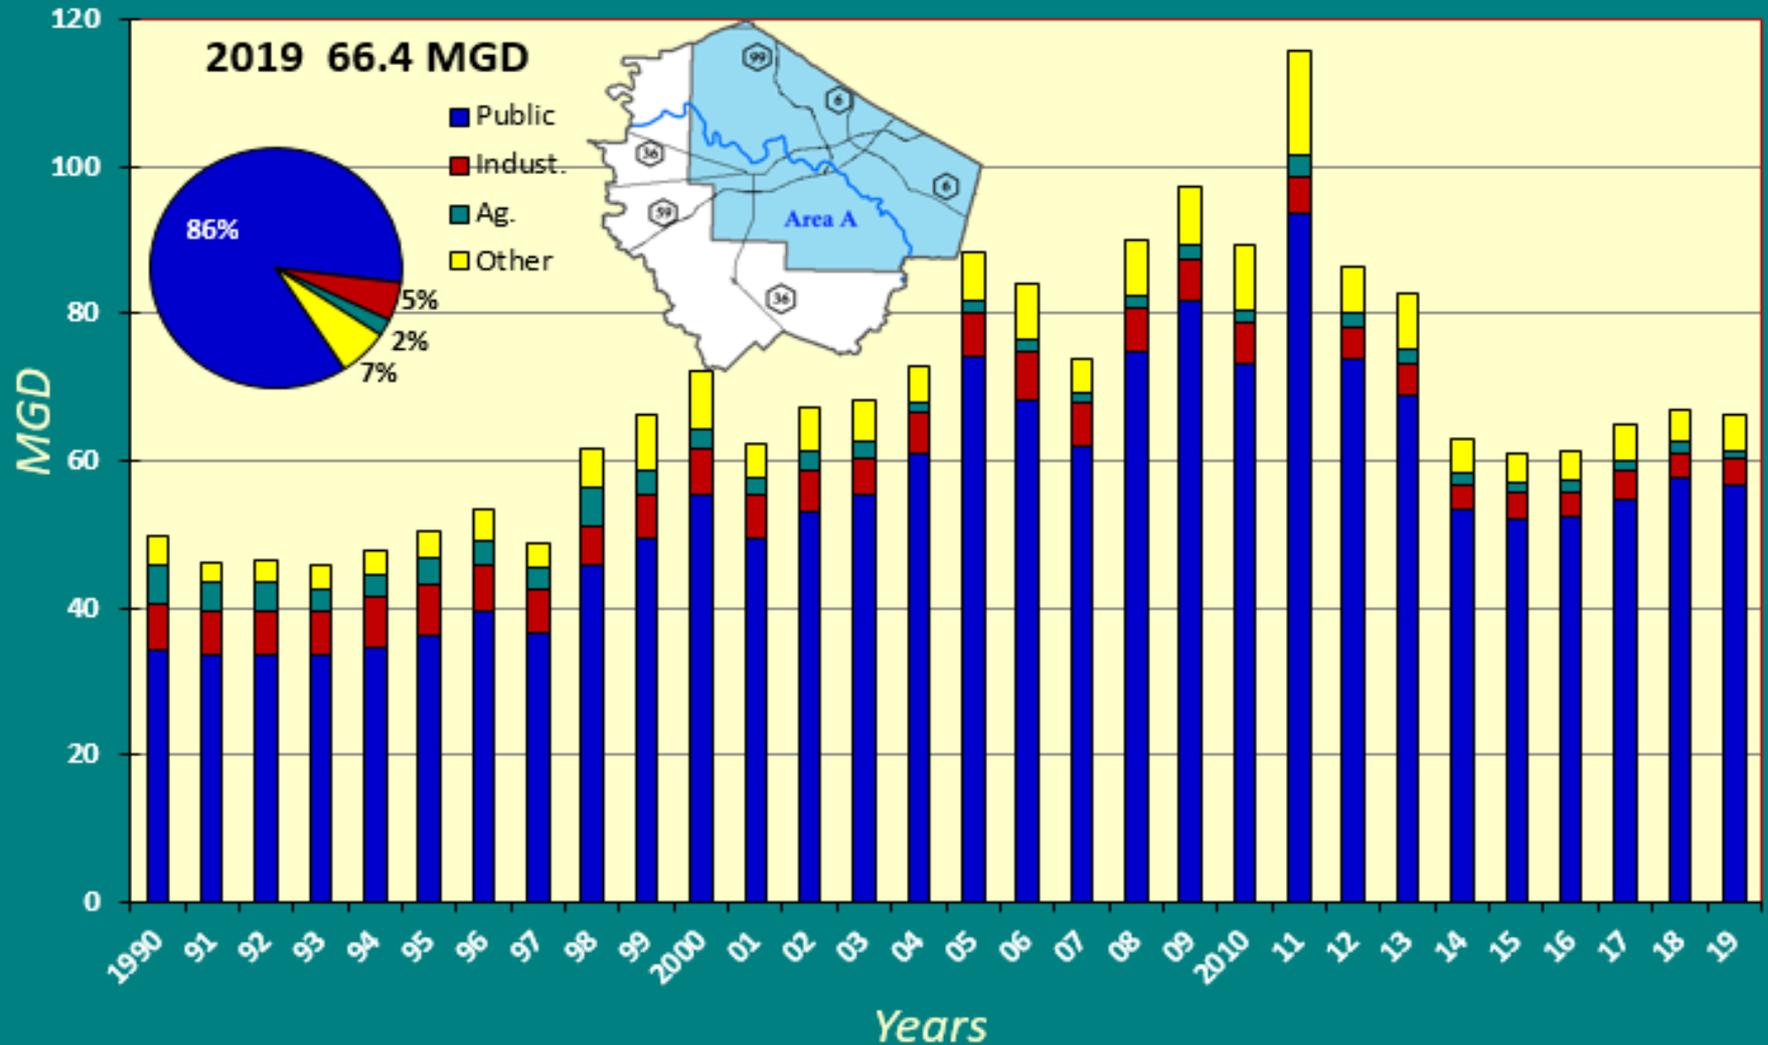
Groundwater Withdrawals

Grouped by Use - Regulatory Area A

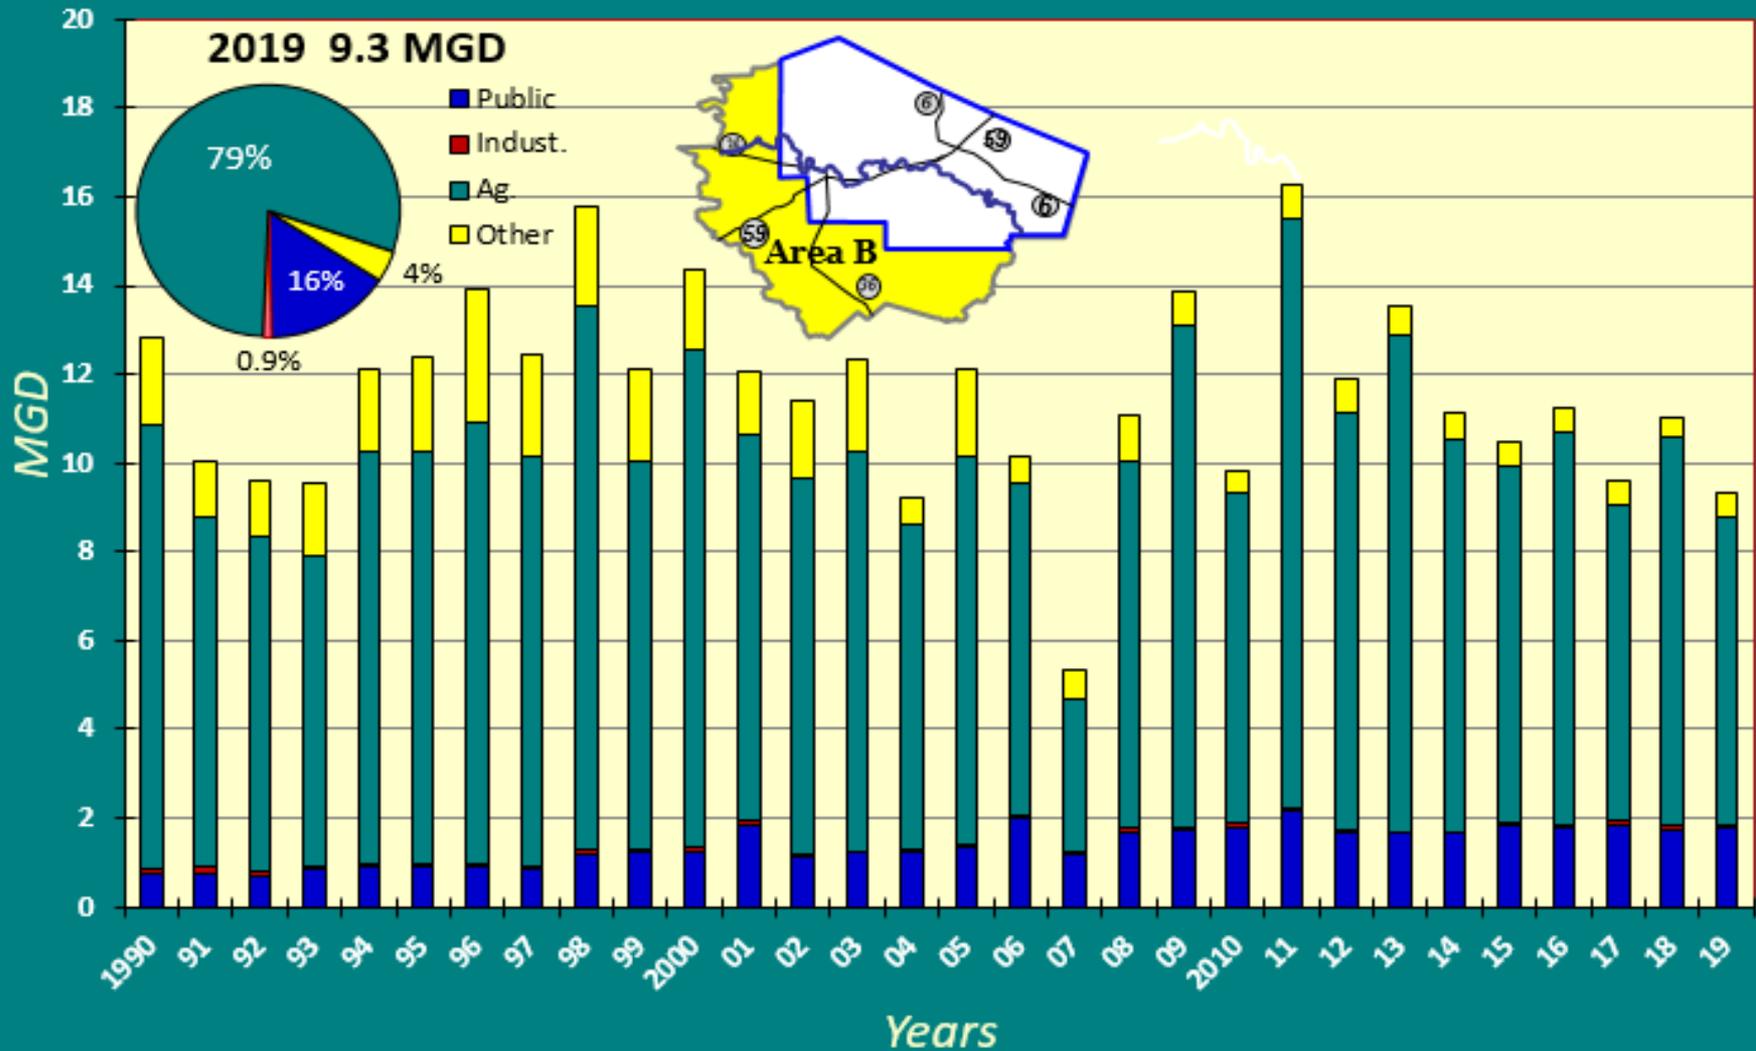
Groundwater Withdrawals

Grouped by Use - Regulatory Area B

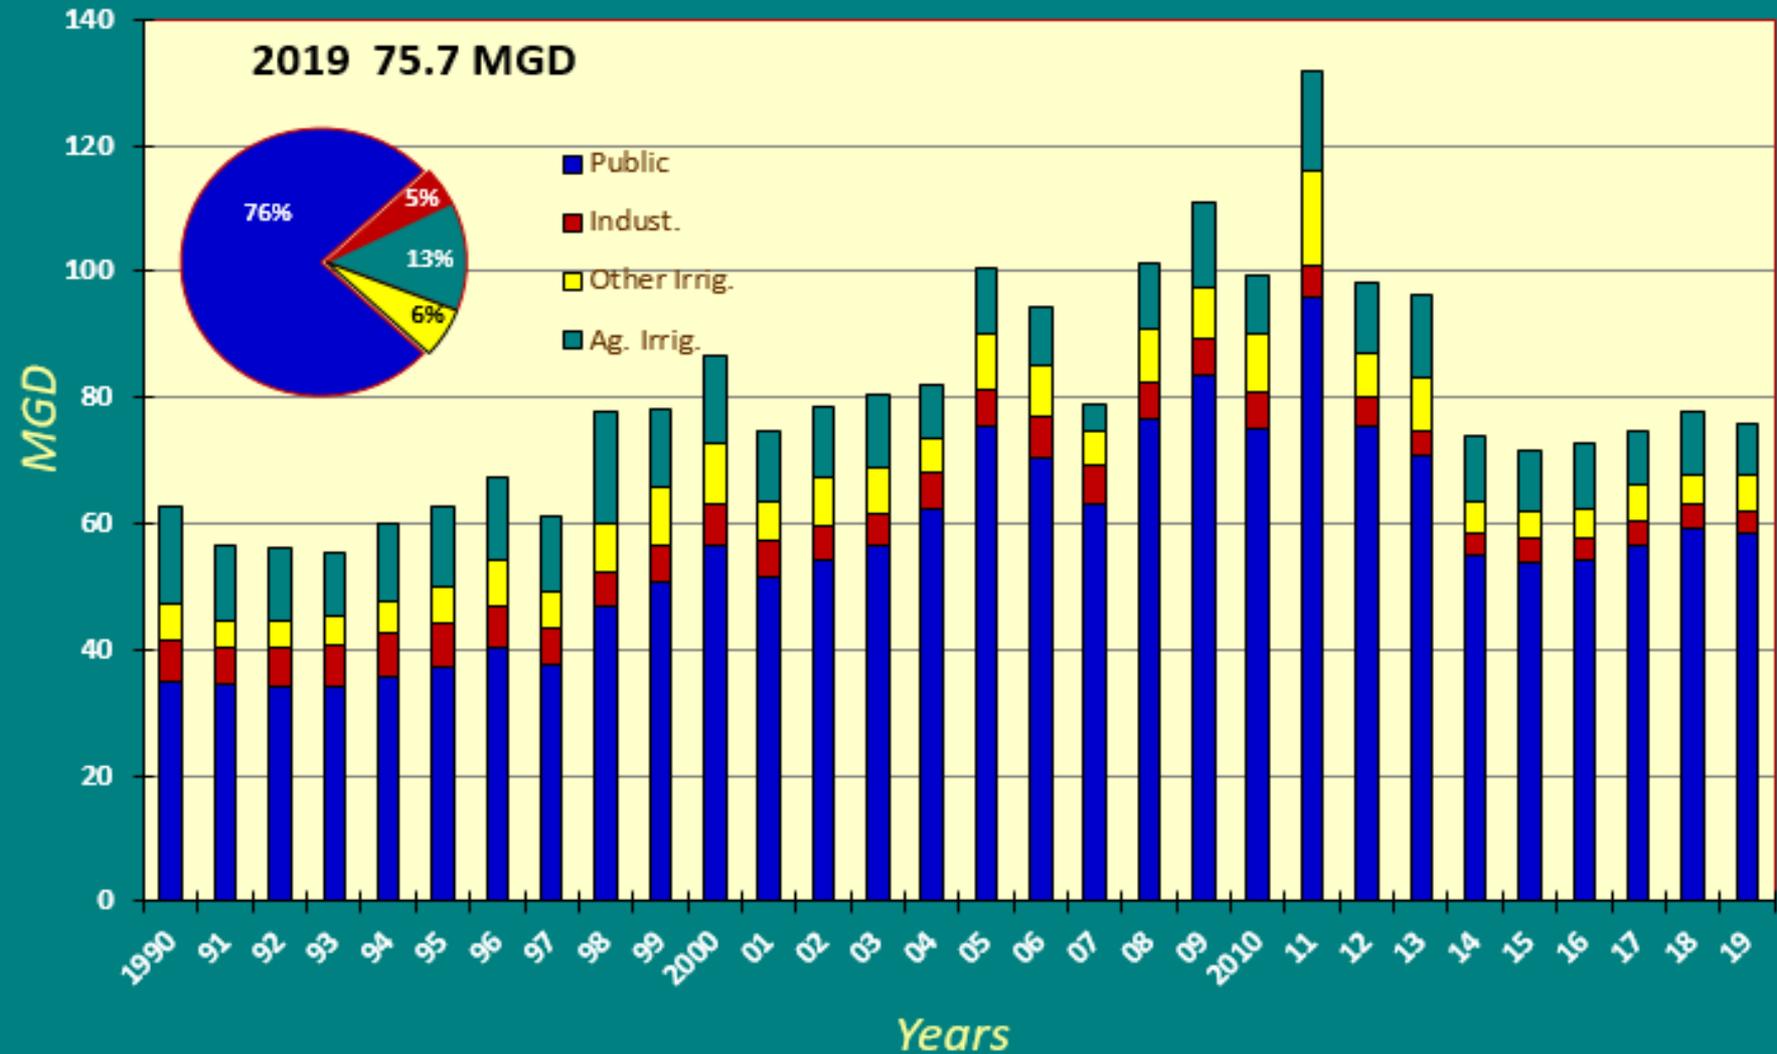
Groundwater Withdrawals

Grouped By Use - Entire District

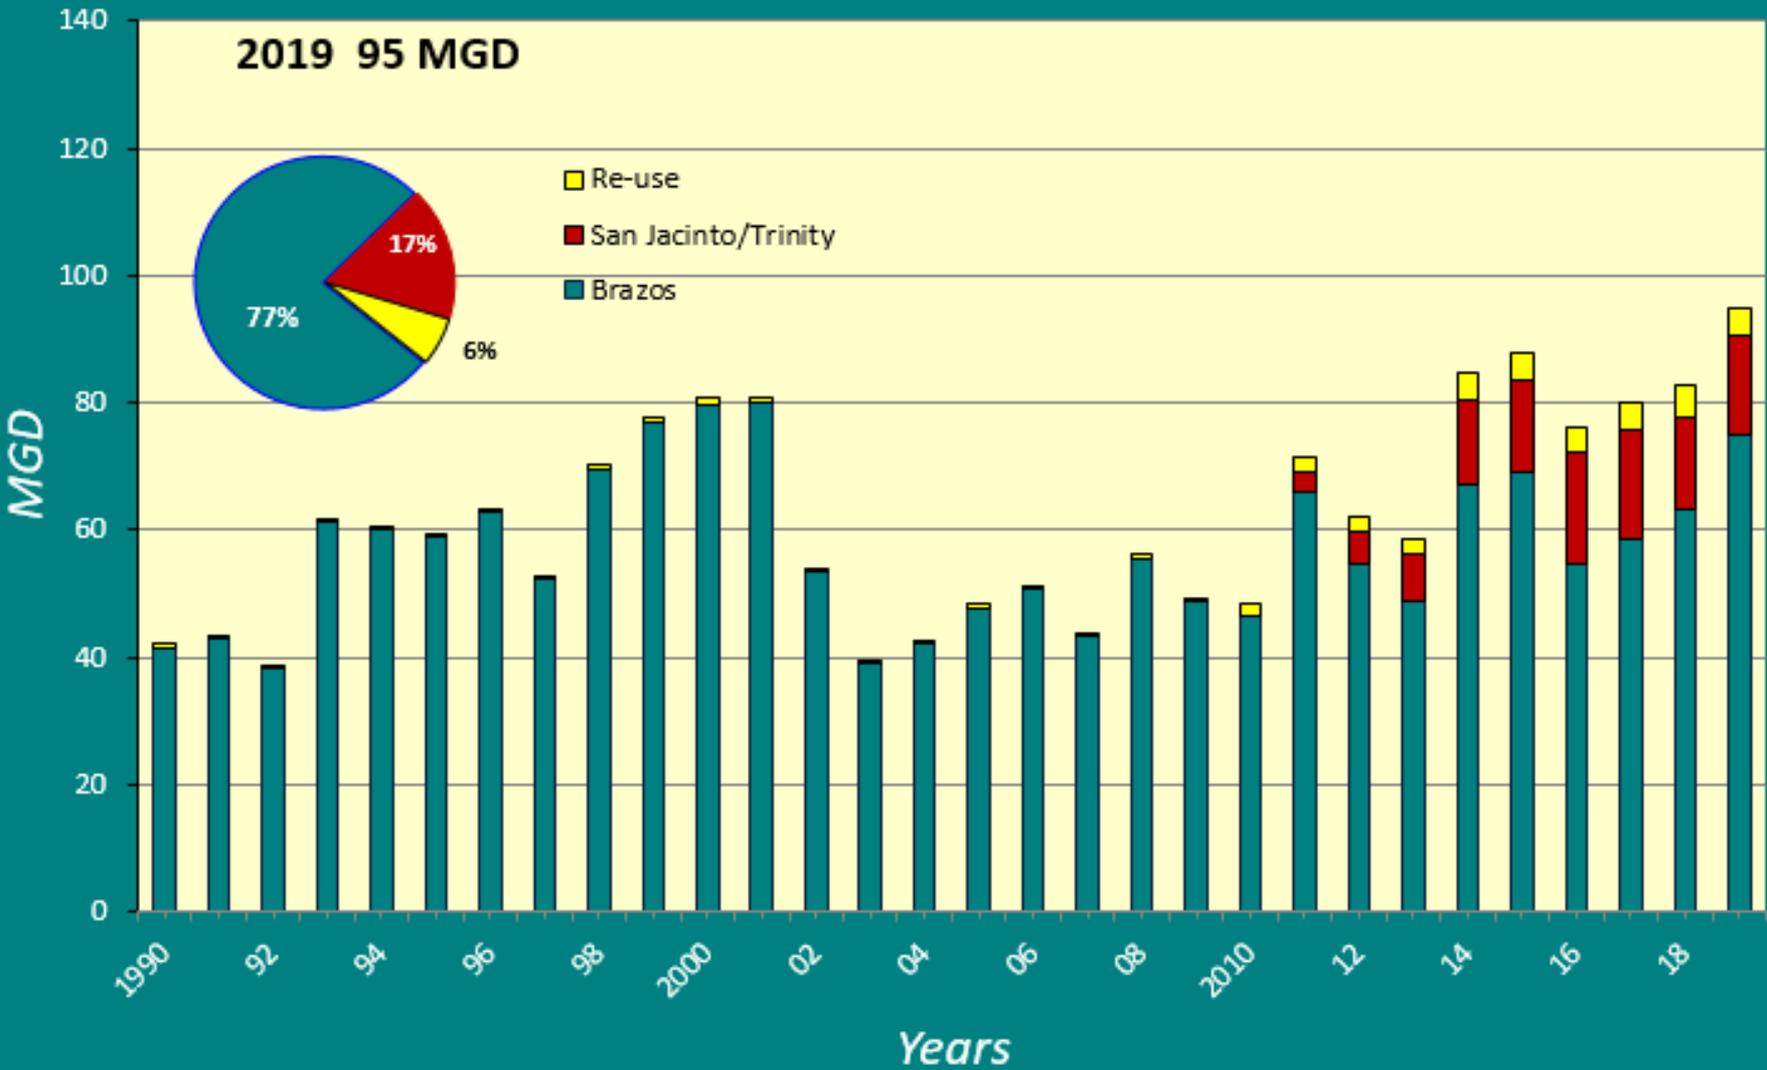
Surface & Re-Use Water Utilized

Grouped By Source - Entire District

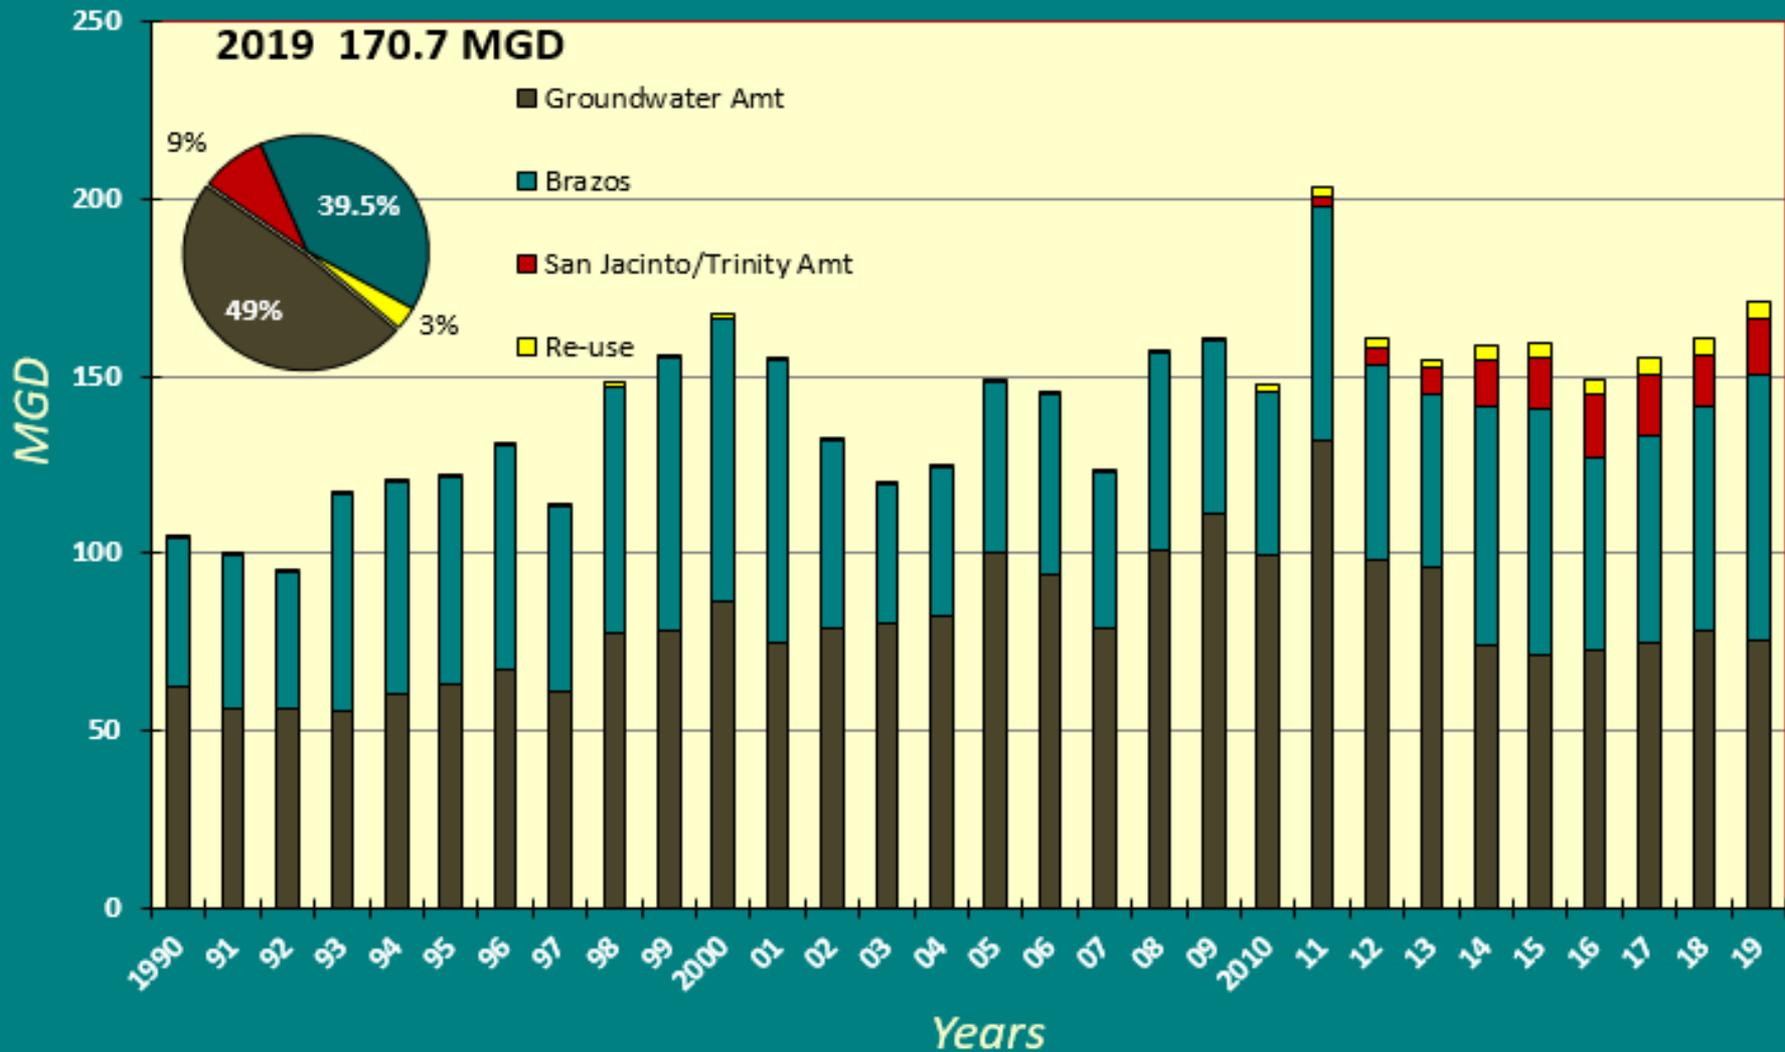
Total Water Demand

Grouped By Source - Entire District

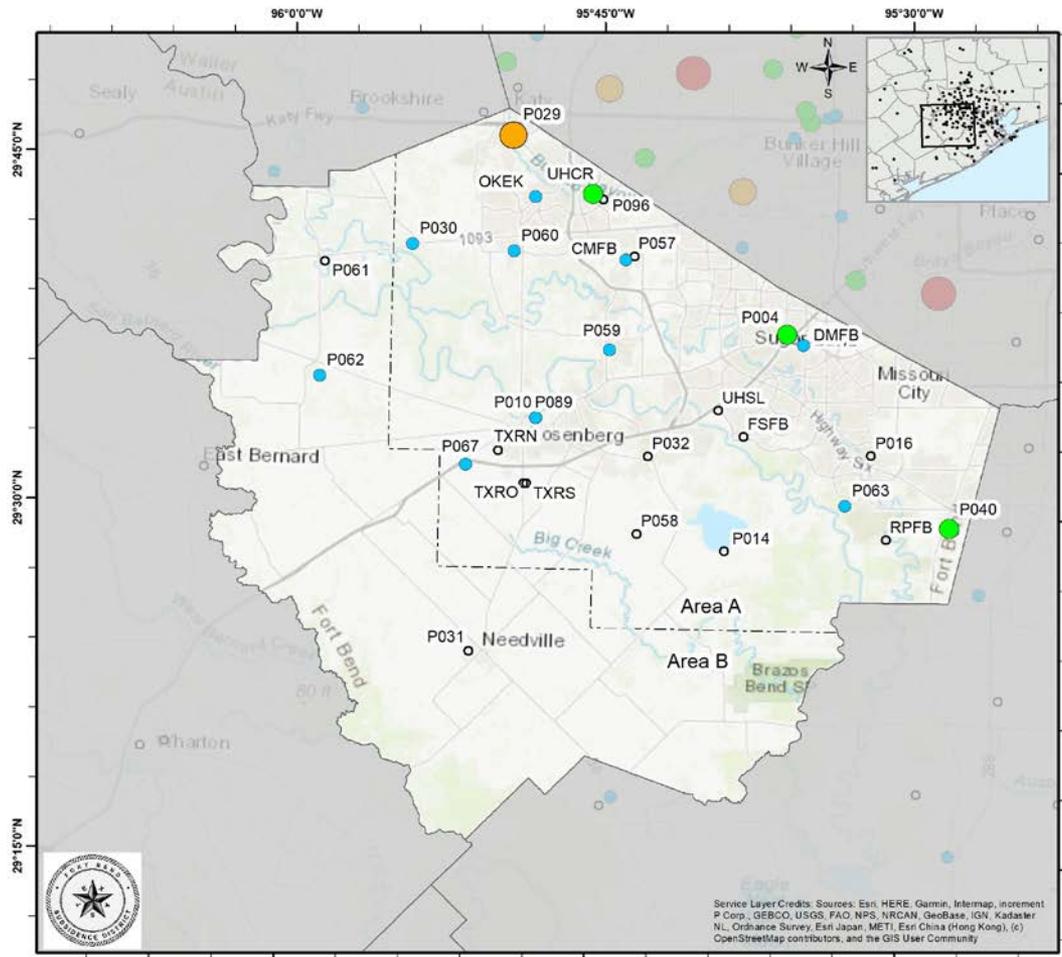
Subsidence Rate (cm/yr) from 2015 to 2019

Annual subsidence rate, in centimeters per year, estimated from periodic and continuous GPS data measured at GPS monitoring sites in Fort Bend and Surrounding Counties, Texas, 2015-2019.
